WEST VIRGINIA OFFICE OF MINERS' HEALTH, SAFETY AND TRAINING

REPORT OF FATALITY

November 10, 2014

RED BONE MINING COMPANY

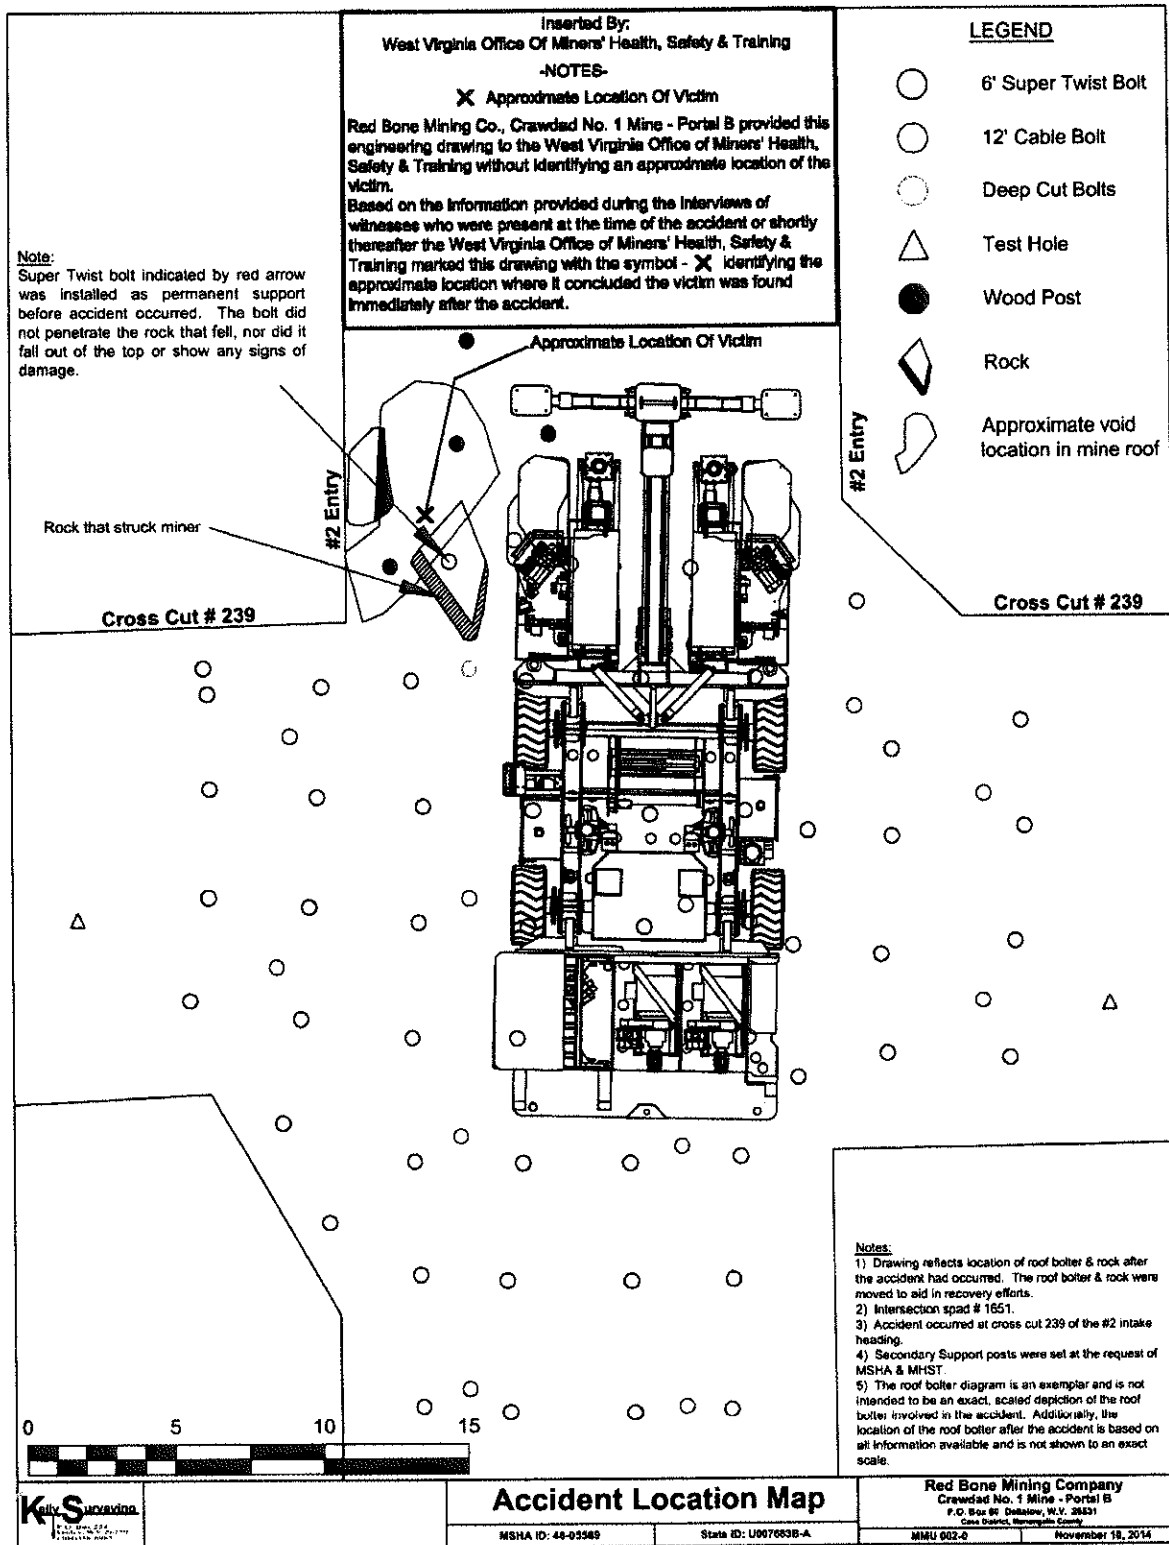
MAPS OF ACCIDENT SITE 1, 2

5. The accident occurred on the #2 North section, in the first cut extracted in the #2 entry, #239 crosscut, just inby spad station #1651.
6. Mr. Savage was bolting with Mr. Belanger and had installed one row of permanent roof bolts in the #2 entry prior to the accident.

20. Mr. Savage received fatal injuries when he was struck by a large piece of roof rock that had dislodged from the mine roof. The cavity where the rock dislodged was located inby the last row of permanent roof supports and outby the A.T.R.S.

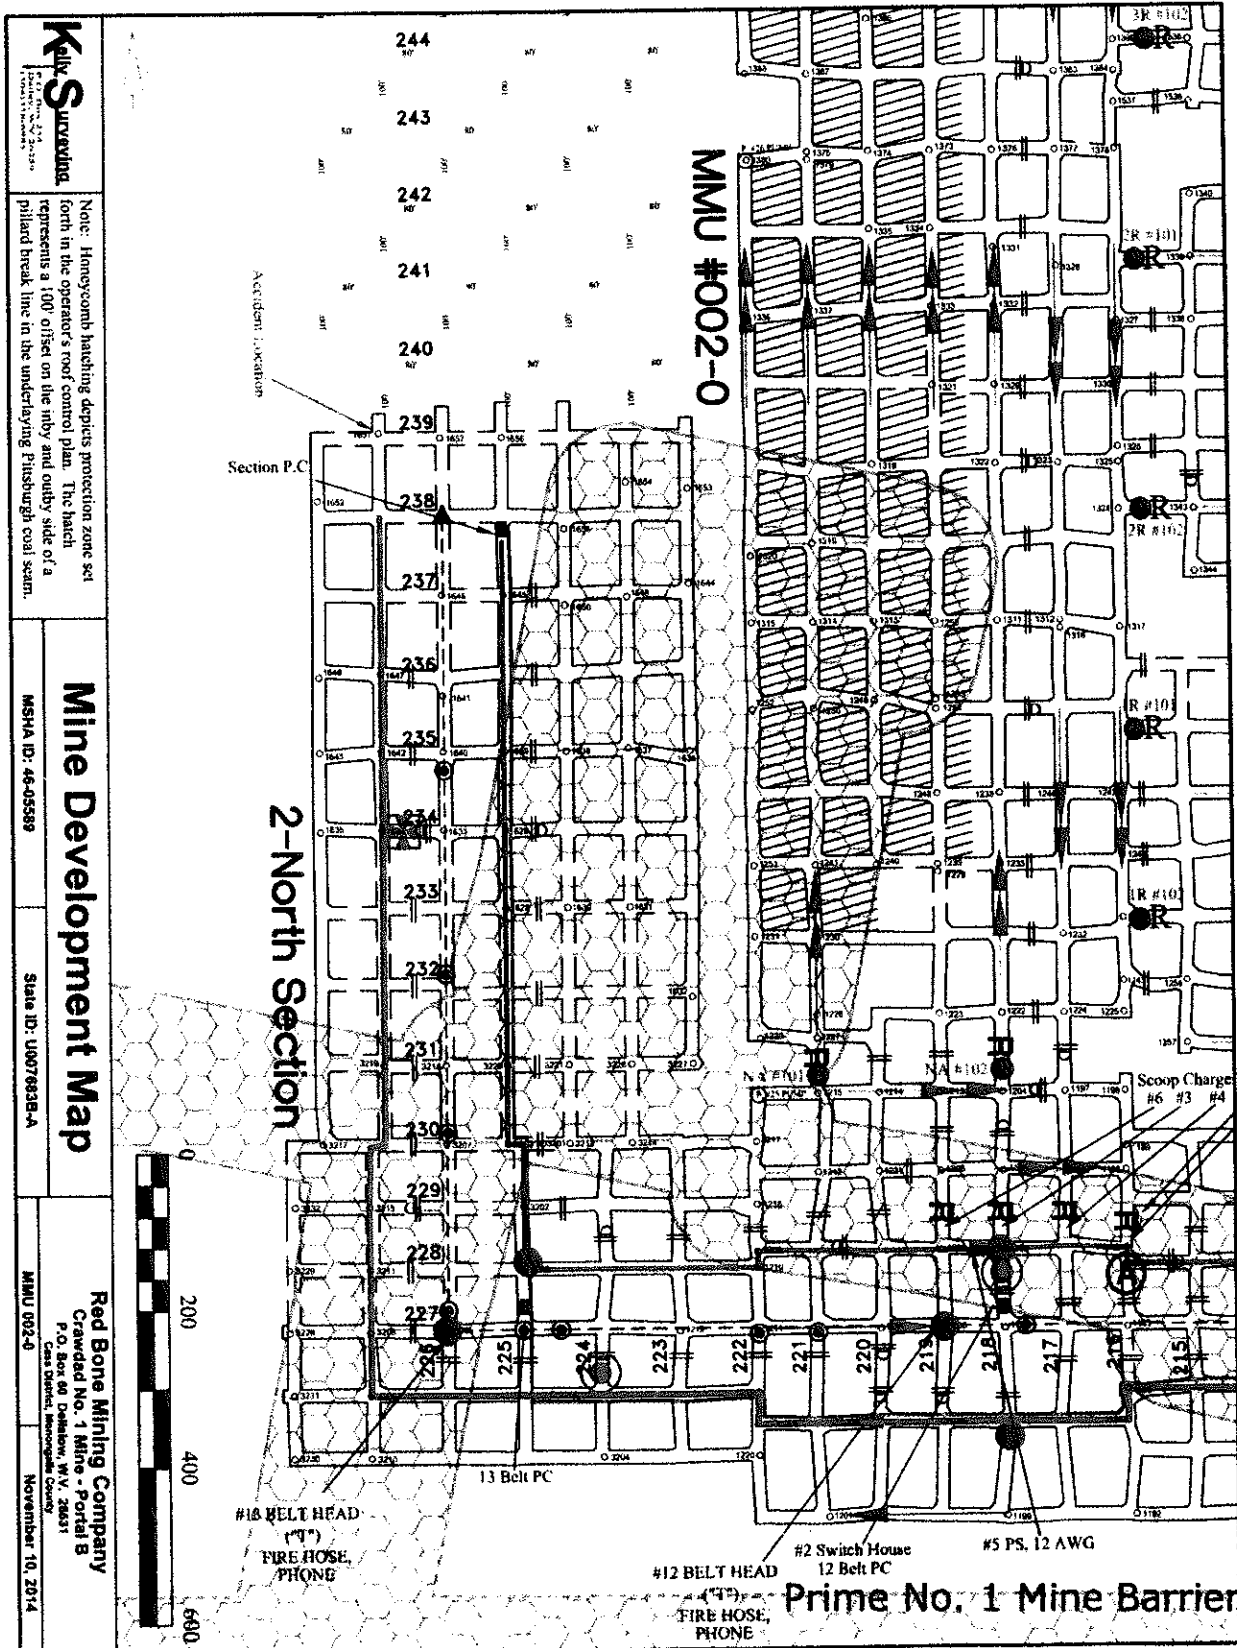
8. The Pittsburgh coal seam is located below the Sewickley coal seam and had previously been mined.
9. The six (6) foot, Super-Twist Torque/Tension and the twelve (12) foot cable bolts are required when mining above the Pittsburgh coal seam where longwall or pillar mining had been performed with evidence of partial mining or when barrier pillars exist. Engineer's maps identify these areas by "honeycombed" colored areas plotted on the mine map. (Reference map on page 2)

12. Six (6) foot, resin grouted roof bolts, four (4) per row, were being installed when not mining above "honeycombed" areas.
13. The engineer's map reveals that the left side of the #2 North section was not above longwall or pillar mining where extra and additional supports were being installed. The #2 entry is seven (7) crosscuts and approximately six hundred and seventy (670) feet inby the "honeycombed" area.
