**West Virginia Office of Miners' Health Safety and  
Training**

**Report of Investigation  
Underground Coal Mine Fatality  
(CRUSHING)**

**White Buck Coal Company  
Pocahontas Mine  
Permit Number U00300705A**

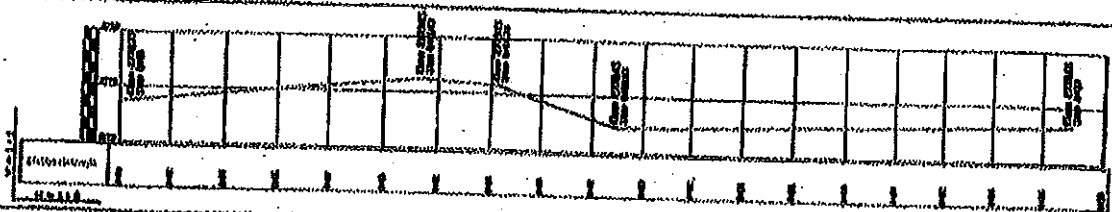
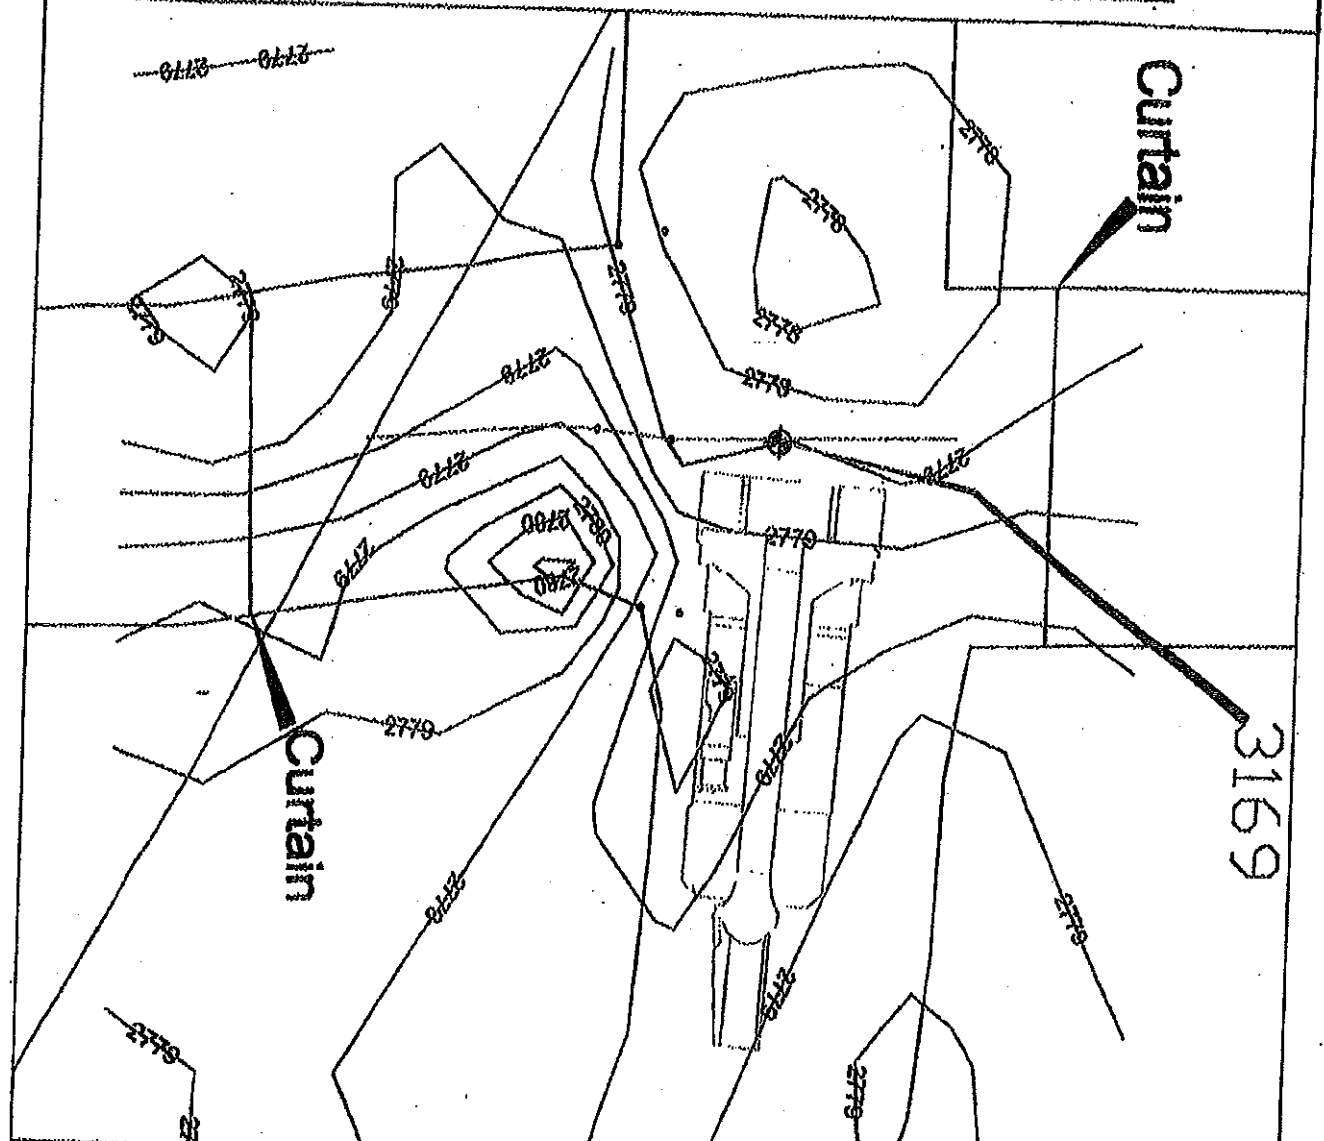
**POCA 2 UNIT**  
**11/30/12**  
**1" = 10'**

**Floor Elevations & Contours**

No. 6 entry. They turned outby in No. 6 entry and traveled for one break, again turning and traveling through the No. 6 to No. 7 crosscut. The No. 6 entry from the last line of crosscuts outby for one break is a slight incline and the bottom conditions are moist to wet.

The maintenance scoop traveling batteries end first, turned from the No. 6 entry into the No. 6 to No. 7 crosscut and momentarily lost traction due to the combination of grade and moist to wet bottom conditions. Aaron Childers saw Steven O'Dell travel around the corner from No. 6 entry into the No. 6 to No. 7 crosscut towards the No. 2 continuous miner. As the maintenance scoop gained traction, Aaron Childers continued around the corner from No. 6 entry into the No. 6 to No. 7 crosscut at approximately 1:19 A.M. and preceded through the fly pads. After the operators compartment of the maintenance scoop had completely cleared the fly pads, Aaron Childers felt the scoop hit the No. 2 continuous miner (he stated he did not see it). Aaron moved the maintenance scoop away from the No. 2 continuous miner got out of the scoop and went to the continuous miner and observed Steven O'Dell lying on the mine floor between the battery end of the maintenance scoop and the left side drum of the No. 2 continuous miner. Aaron immediately went for help. He found Harold Fain and Shawn Hamrick (EMT'S) near the section power center.

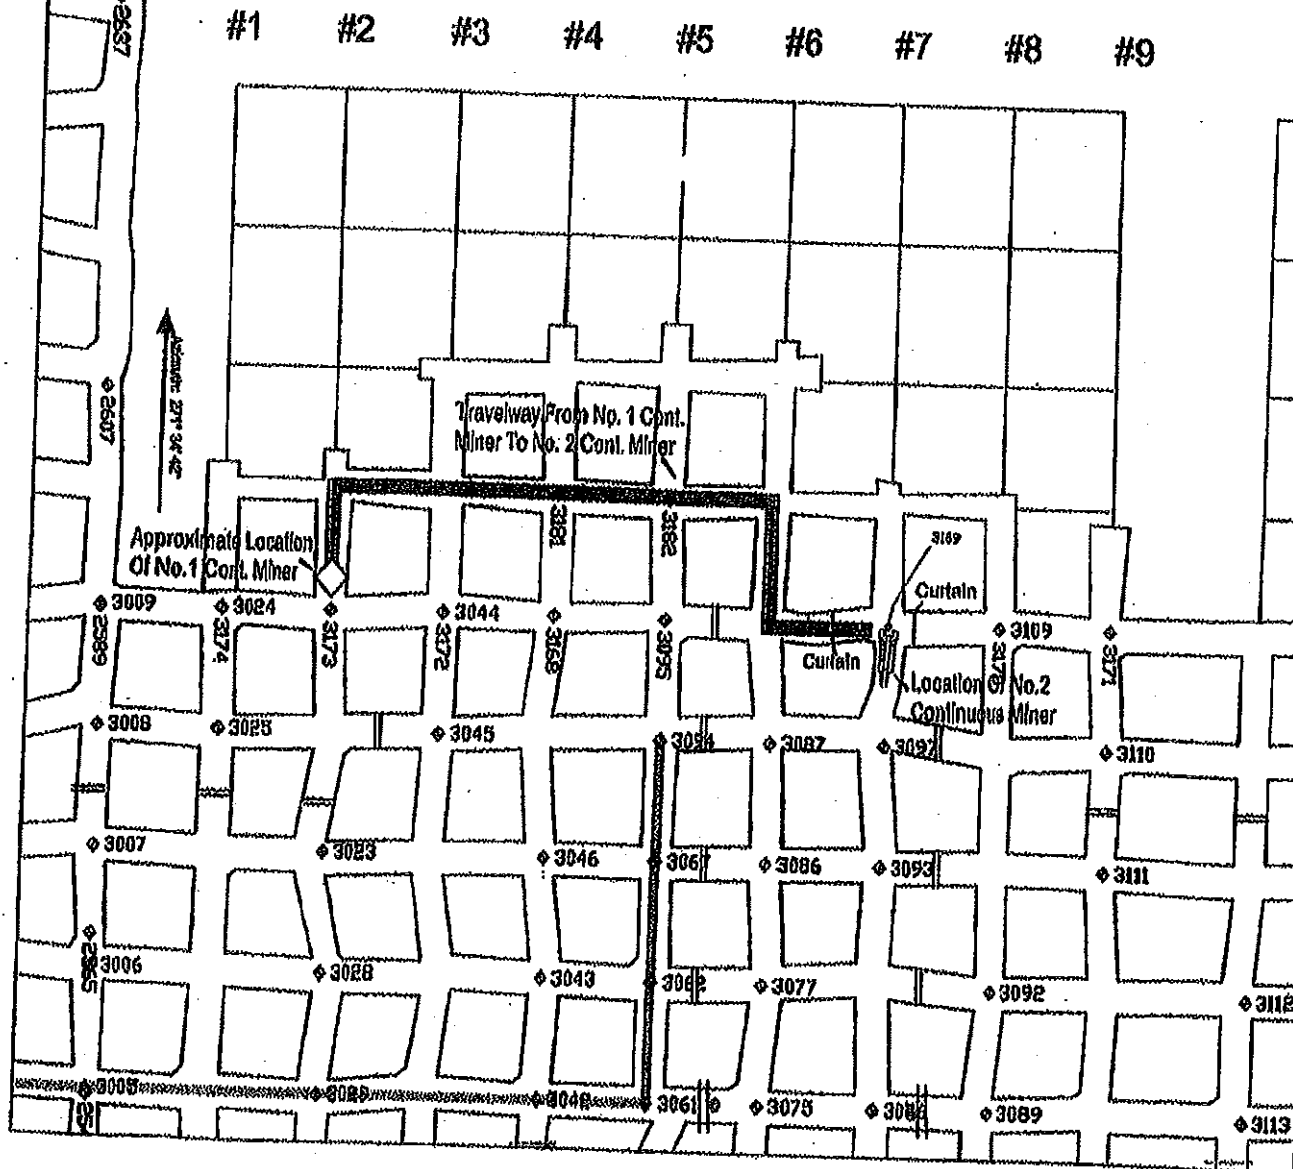
Travel Route Of Maintenance Scoop  
T3994921025  
From No.1 Continuous Miner  
To No. 2 Continuous Miner

At approximately 1:17 AM, both Aaron Childers and Steven O'Dell left No. 2 entry to travel to No. 7 entry to complete the work on the No. 2 continuous miner. Steven O'Dell walked to No. 7 entry while Aaron Childers operating the maintenance scoop followed Steven O'Dell across the section. They traveled via the last open line of crosscuts (see drawing page number 5) to the
