West Virginia Office of Miners' Health, Safety and Training

October 28, 2007

Struck by Material Fatality
Long Branch Energy
Mine No. 23
Permit No.: U-143-82-A

Region Three – Danville Office
137 Peach Court, Suite 2
Danville, WV 25053
Eugene White, Inspector-at-Large

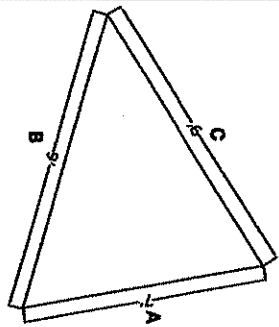
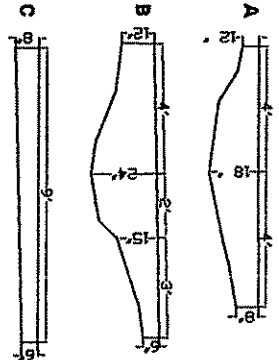
FATAL ACCIDENT

TOP ROCK

* APPROXIMATE ROCK LOCATION PRIOR TO INCIDENT

BOTTOM ROCK IS APPROXIMATELY 9" THICK

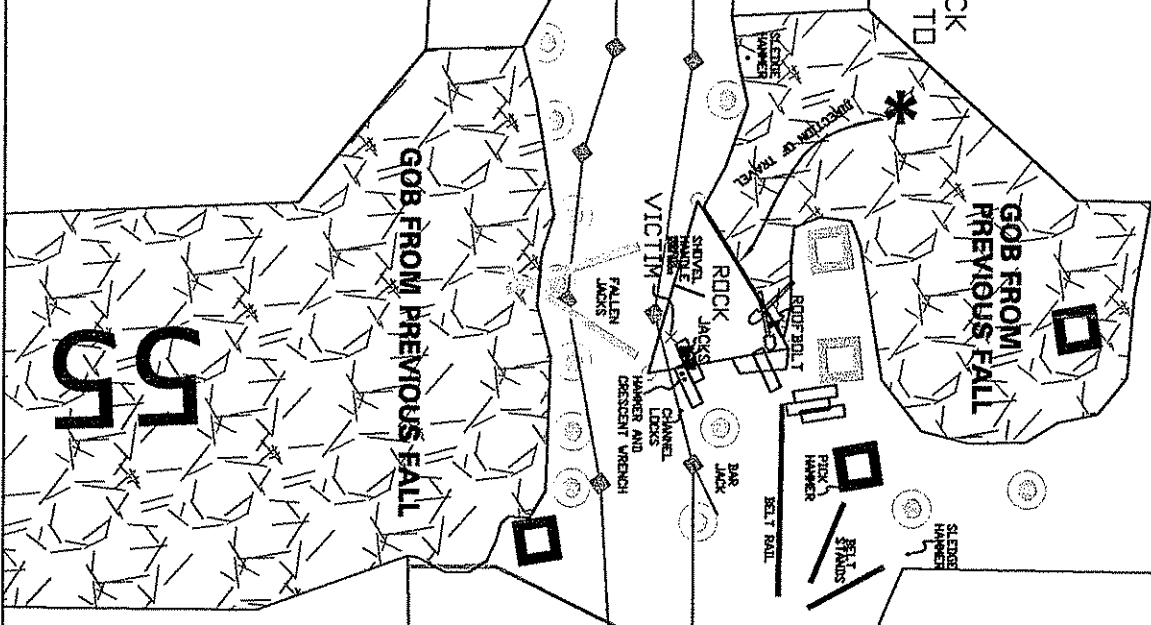
LOCATION:
BREAK 55 AT STATION 220

1. Mine No. 23 is owned and operated by Long Branch Energy.
2. The accident occurred on the No. 4 belt at crosscut No. 55.
3. A roof fall occurred on October 7, 2007, resulting in the large rock standing alongside the belt.
4. The large section of rock measured nine feet by seven feet by six feet.
5. Mr. Keeney was shoveling alongside the No. 4 belt when the rock toppled over.
6. The large piece of rock was in a vertical position against a 100 ton Henitzmann jack.
7. No contributing violations were issued as a result of the investigation.

Mr. Charles Jason Keeney, age 34, was fatally injured when he was crushed by a large section of rock. The rock measured nine feet by seven feet by six feet. The rock was positioned alongside the No. 4 belt when it suddenly toppled pinning Mr. Keeney against the frame of the No. 4 belt. Mr. Keeney and two other employees had been cleaning the walkway along the No. 4 belt when the accident occurred.

28. If rehabilitation work is to be performed in the walkway or roadway next to conventional support (floor to roof support) where roof or rib failure has occurred, the following safety precautions will be observed:
- (A) A certified person will examine the area to be rehabilitated.
 - (B) Specific clean-up and support procedures will be developed and posted at the work site.
 - (C) All persons assigned to perform the rehabilitation work will be instructed in the clean-up and support procedure.
 - (D) All persons who perform the rehabilitation work will be experienced in this work or directly supervised by a person experienced in this work.
