West Virginia Office of Miners' Health, Safety and Training

April 7, 2006

Fatal Underground Track Haulage Report
Southern West Virginia Resources, LLC
Spruce Creek Mine
Permit No. U-5785-AA

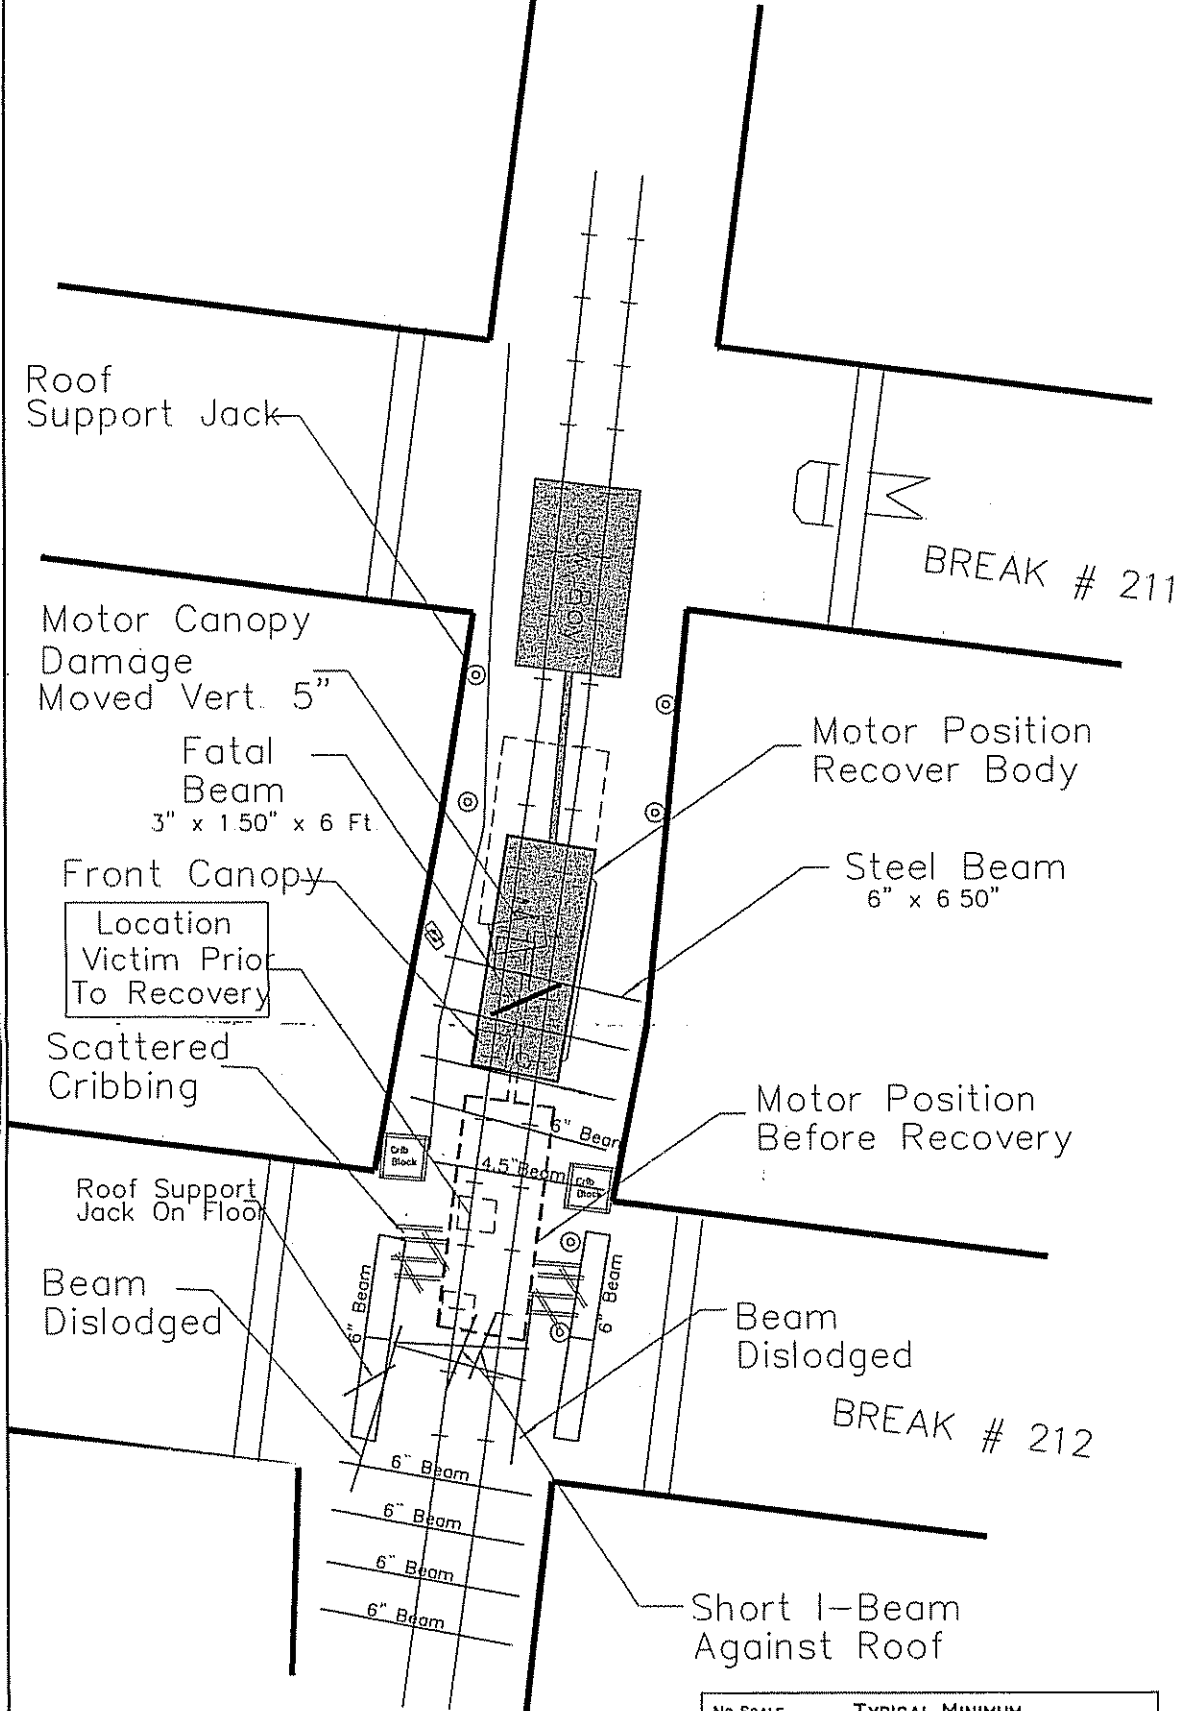
ACCIDENT - FATAL
JACOB MINING CO., LLC.

Mr. Robert Runyon, 48, was fatally injured when an unsecured 4 inch I-beam, approximately 72 inches in length, used as flooring for supplemental roof support became dislodged and impaled the victim while he was operating a Goodman 14-ton Track Star rail locomotive at break no. 212 along the Marrowbone Creek track haul way. The motor was being used to haul equipment being dismantled from the Tom's Branch switch to the Marrowbone Creek portal.
