West Virginia Office of Miners' Health, Safety and Training

February 10, 2004

Fatal Surface Haulage Investigation Report  
Colony Bay Coal Company  
Colony Bay Surface  
Permit No. S-5009-89

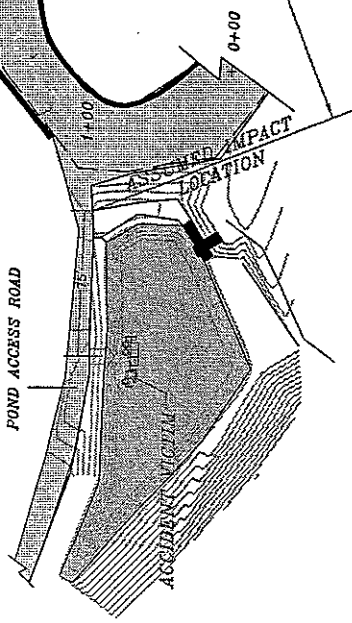
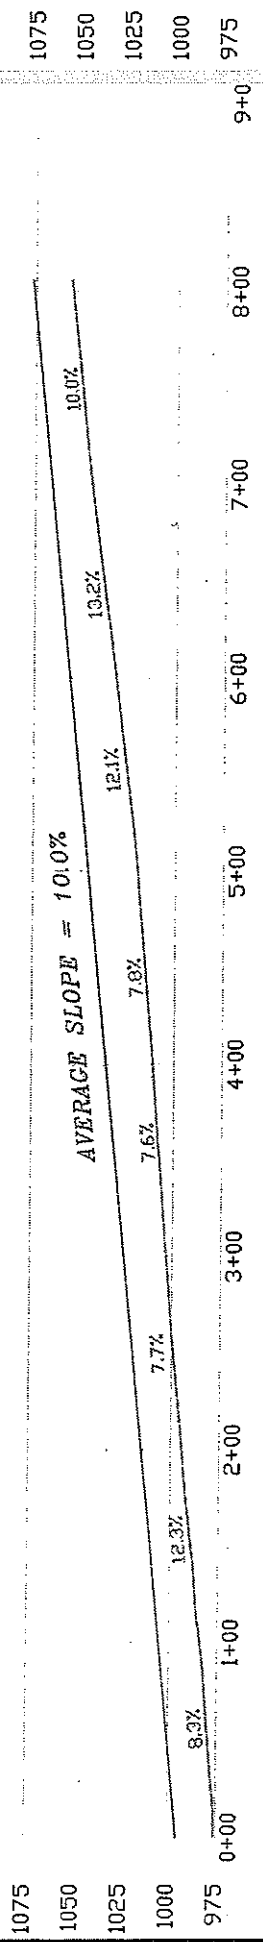
MAP SHOWING  
LUB-TRUCK ACCIDENT  
COLONY BAY COAL COMPANY  
FEB. 10, 2004

ASSUMED START OF BRAKE  
LOSS LOCATION

CAUSE OF ACCIDENT: The victim was descending the main access road in a service truck when the truck's braking system failed. The apparent brake failure resulted in the service truck's hitting the berm alongside a sediment pond, traveling approximately 70 feet up the pond road and sliding into the pond. The service truck landed on the driver's side in about 10 feet of water.
