June 5, 2008

Fatal Power Haulage Accident
Underground Coal Mine

Consolidation Coal Company
Robinson Run Mine
D-4786-S

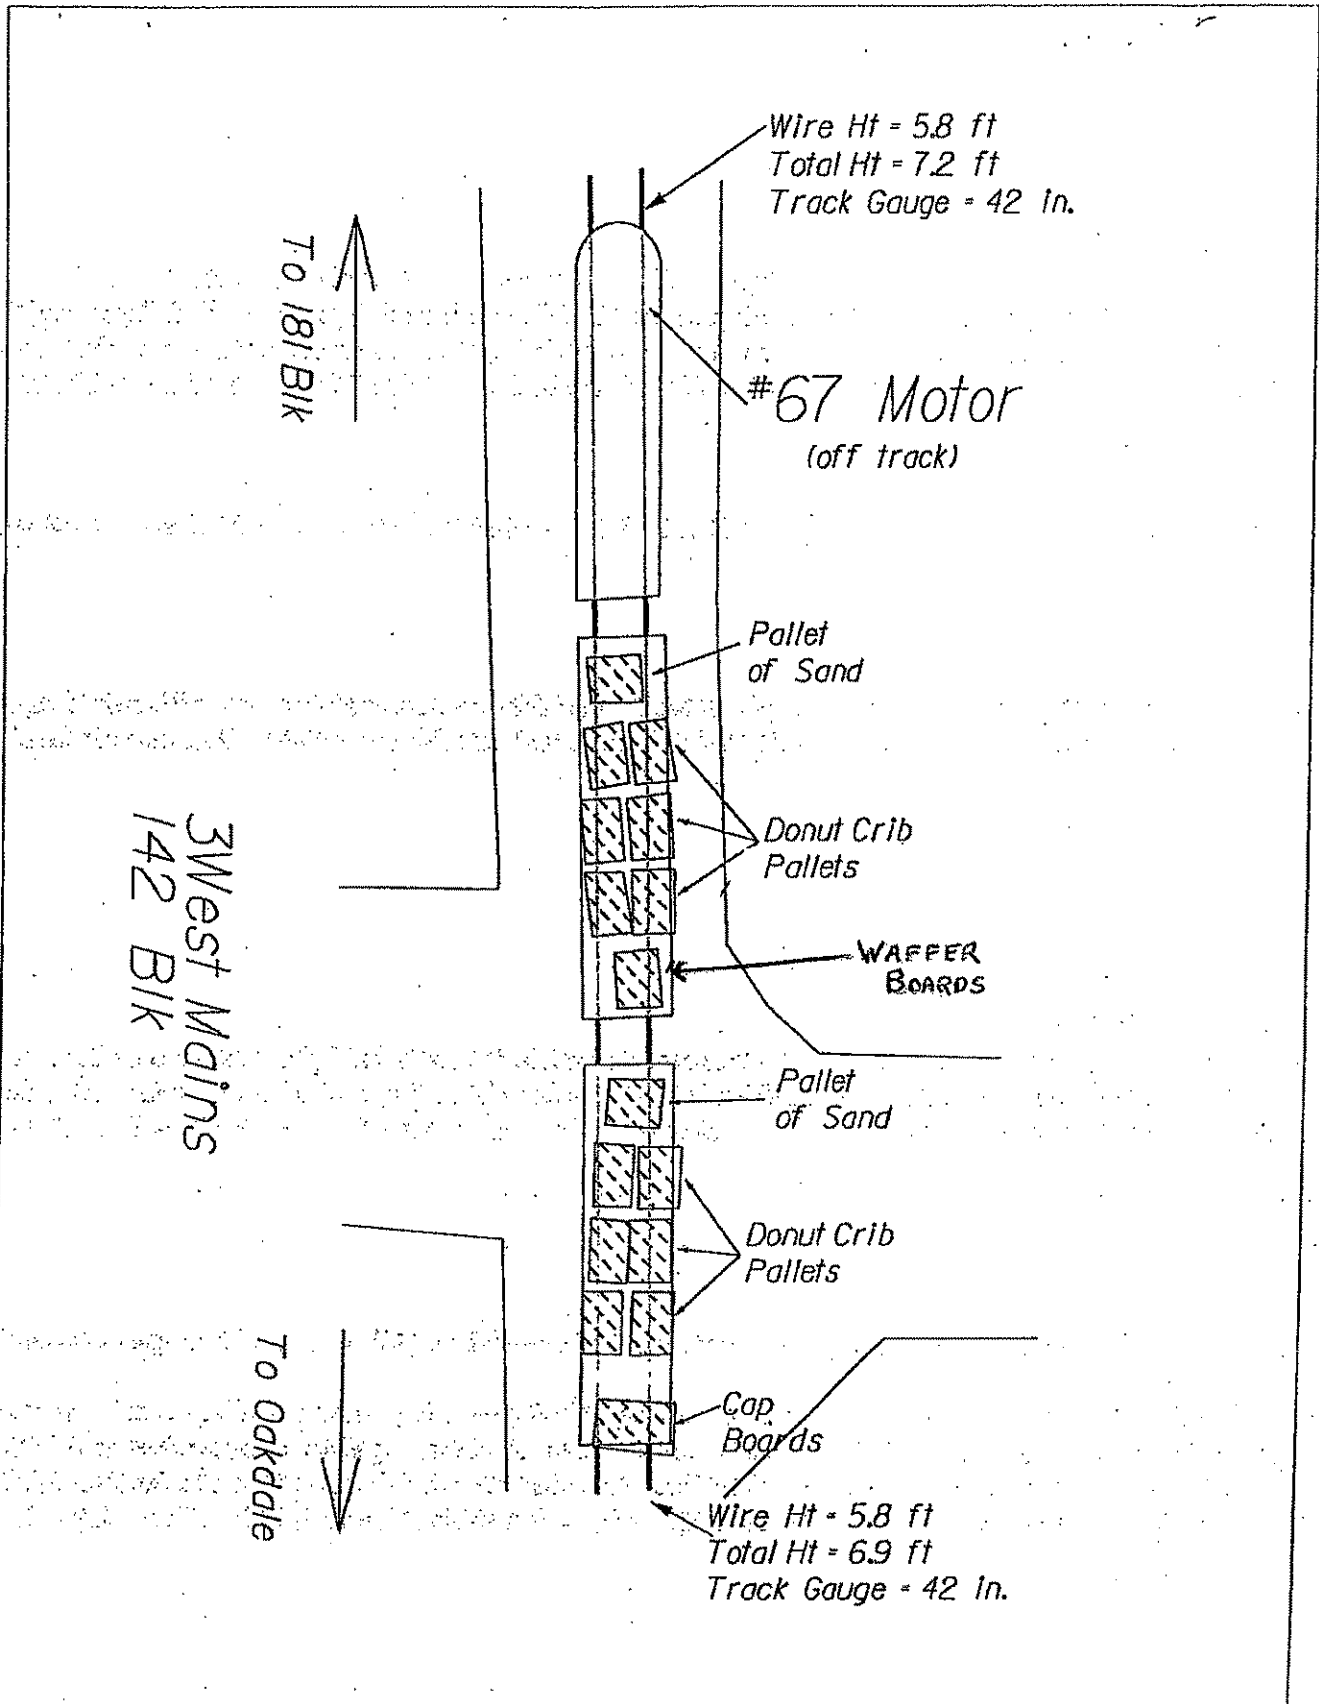
Final Location of Motor & Cars

- 1) The General Electric 20 ton track locomotive, Model GEX-10873, Serial No. 38927 (company number 67) was being utilized to haul two supply cars to the seal project at 174 block.
- 2) The two shield carrier type supply cars were loaded with a total of twelve pallets of doughnut cribs, two pallets of sand, and one pallet of cap boards.
- 3) The total weight of the supply cars and materials was 43.32 tons.
- 4) The 3 West haulage track from 90 Block to 130 Block is 3,700 feet in length and drops approximately 125 feet in elevation.
- 5) Evidence indicated that the outby set of trucks on the #67 locomotive came off track at #141 Block.
- 6) The #67 locomotive traveled a distance of approximately 253 feet inby the #141 block before coming to a stop.

- 7) The inby set of trucks on the #67 locomotive came off track a short distance prior to the locomotive coming to a complete stop.
- 8) Neither of the two supply cars derailed during the accident.
