West Virginia Office of Miners' Health, Safety and Training

September 3, 2007

Roof Fall Fatality
Consol of Kentucky Inc.
Bronzite Mine
Permit No. U-5038-86B

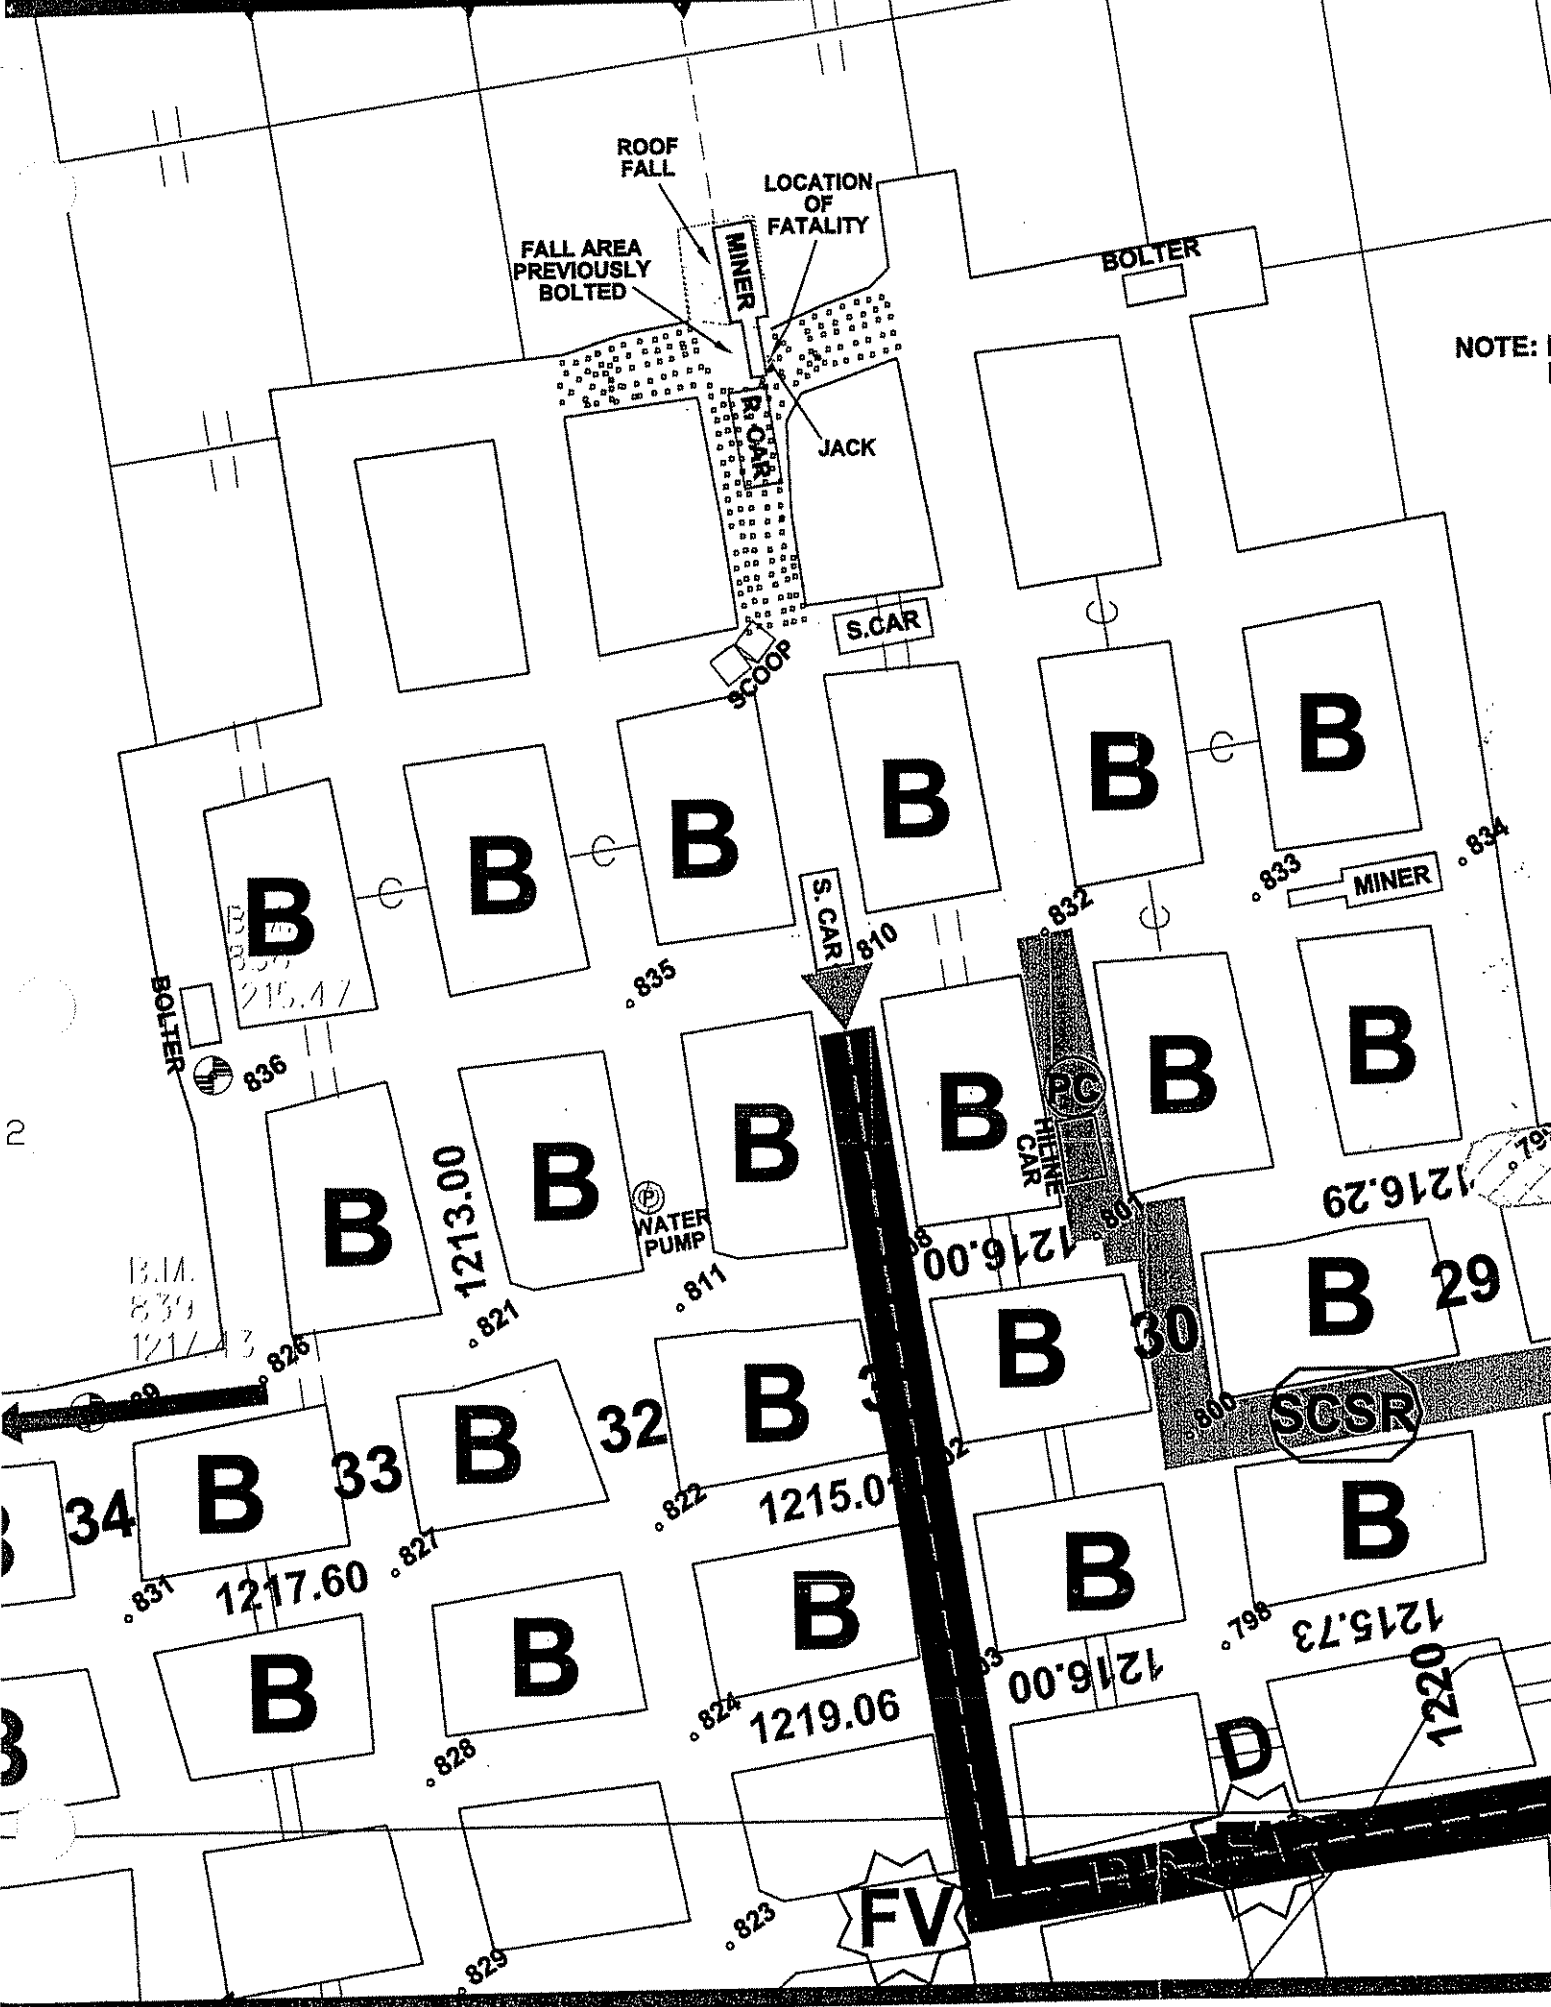
ROOF FALL
FALL AREA PREVIOUSLY BOLTED
LOCATION OF FATALITY
MINER

Mr. Brent Reynolds, age 35, was fatally injured when he was struck by a roof fall. The roof fall originated in a newly mined area and traveled outby into the supported intersection. The fall was approximately nineteen feet wide and four to five feet high in the face area, the fall pulled roof supports as it approached the intersection. The fall traveled approximately fifteen feet into the intersection, involving three to four rows of roof bolts, before stopping. The depth of the fall varied from four to five feet in the face region, tapering to six to twelve inches in the intersection.

1. At the beginning of each newly mined cut of coal, a test hole will be drilled to a depth of ten feet. Additionally, while in the No. 4 Panel, a second test hole shall be drilled to a depth of ten feet in the last full row of bolts.
2. The minimum length of bolt will be a six foot, fully grouted resin roof bolt.
3. Prior to turning a new cross-cut, six cable bolts , ten foot in length, will be installed in each intersection over the location of the continuous miner.
4. When adverse roof conditions are encountered, the depth of the cut will be reduced to effectively control the roof.
