June 5, 2008

Fatal Power Haulage Accident
Underground Coal Mine

Consolidation Coal Company
Robinson Run Mine
D-4786-S

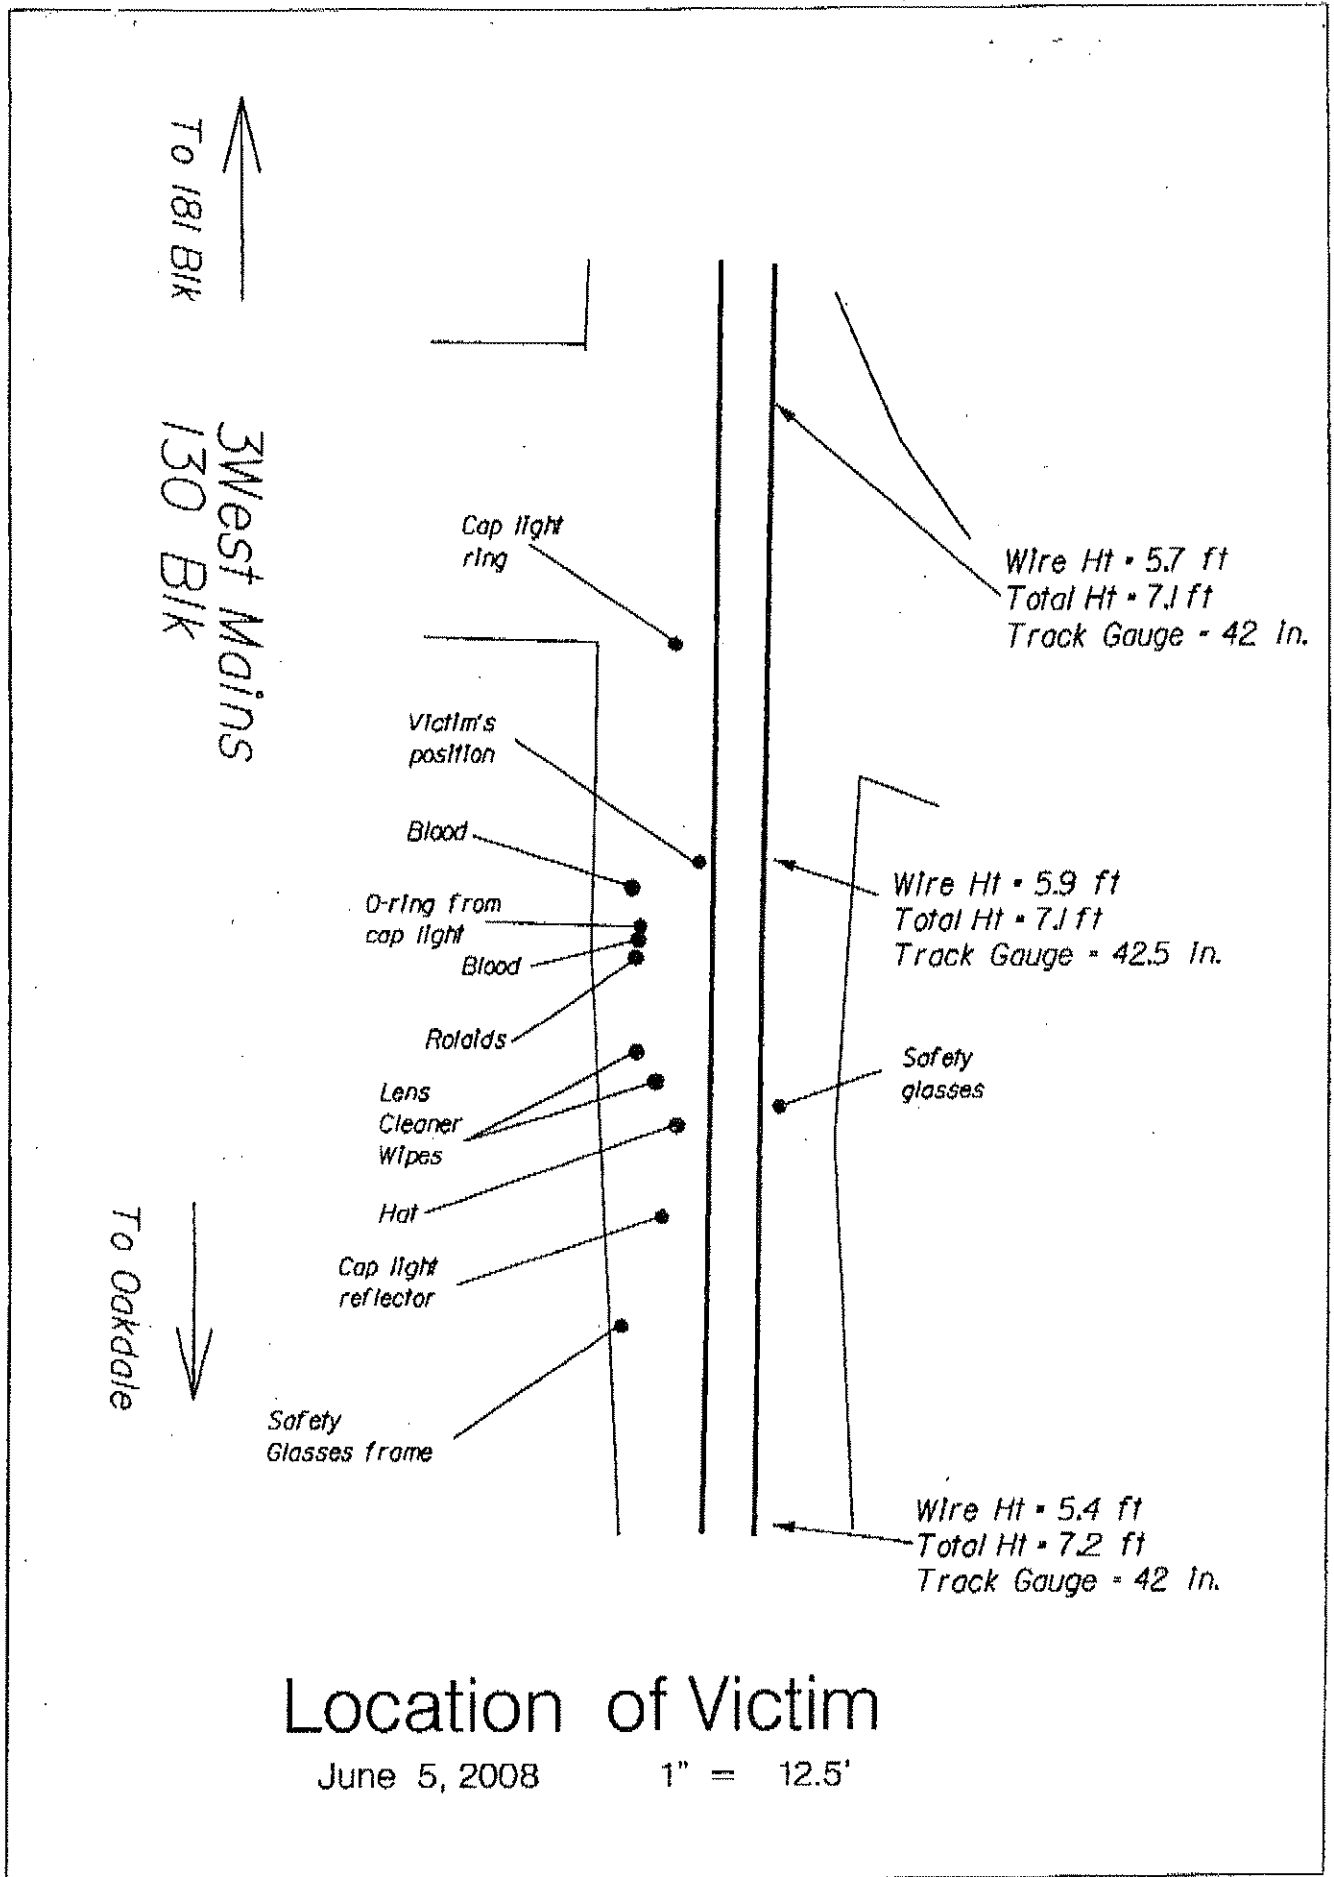
A fatal haulage accident occurred at approximately 10:55 a.m. on June 5, 2008 at the Consolidation Coal Company's Robinson Run Mine. The accident occurred near the 130 block along the 3 West supply track. Mr. Gary A. Hoffman, age 55, was fatally injured when he was struck by a loaded supply car belonging to the trip he was transporting to the 171 block.
